Space Environmental Exposure of IITRI White Thermal Control Paints

27 April 1995

M. J. MESHISHNEK, C. S. HEMMINGER, and S. R. GYETVAY
Mechanics and Materials Technology Center
Technology Operations

SPACE AND MISSILE SYSTEMS CENTER
AIR FORCE MATERIEL COMMAND
2430 E. El Segundo Boulevard
Los Angeles Air Force Base, CA 90245

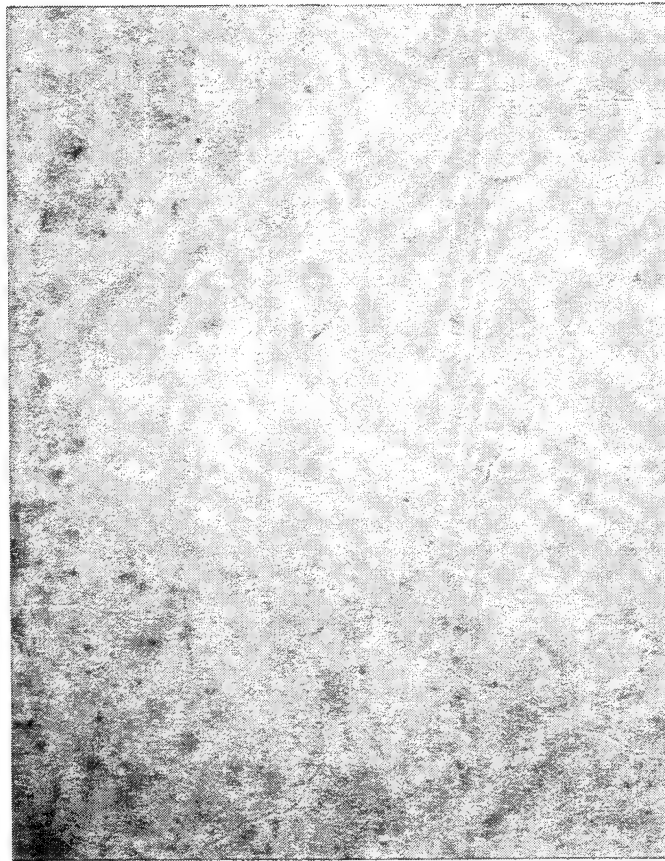
Figure 7. Optical micrograph of mottled and discolored surface of S13GPLO-1, batch R055, sample MM-77, 32 \times magnification.

The S13GPLO-1 test set consisted of two batches, and different results were observed with each. The R055 batch exhibited a slightly lower solar absorptance pretest than the S174 batch, and the values for samples within a batch are fairly consistent. Of major concern, however, is the difference in response of the two batches. The R055 batch gave values roughly 50–60% higher in absorptance than the S174 samples. This translates to almost a factor of 2 in delta α between the two batches. The reasons for this are obvious, but not understood. All four samples of the R055 batch exhibited dark streaks and black lines early in the test, possibly due to arcing of the sample from charging. Figure 7 is a photograph of one of the samples from batch R055. At 32 \times , the streaks appear as a gray mottling

over the brown sample. Why this is not observed in Paint Test 1 is attributed to the difference in electron energy; the higher 40 keV electrons cause more intense charging and arc-over than the 10 and 1 keV electrons. The values for batch R055 from Paint Test 1 in Table 7 were roughly half the post-test absorbance of the samples in Paint Test 2. Clearly, the higher keV electrons produce more damage in the material. Since higher electron (and for that matter, proton) energies and fluxes exist for on-orbit conditions, these results should not be ignored.
